**PHASE I
ENVIRONMENTAL SITE ASSESSMENT**

**The Chatt Inn
2000 East 23rd Street
Chattanooga, Tennessee 37404**

**Re: Phase I Environmental Site Assessment
The Chatt Inn
2000 East 23rd Street
Chattanooga, Tennessee 37404**

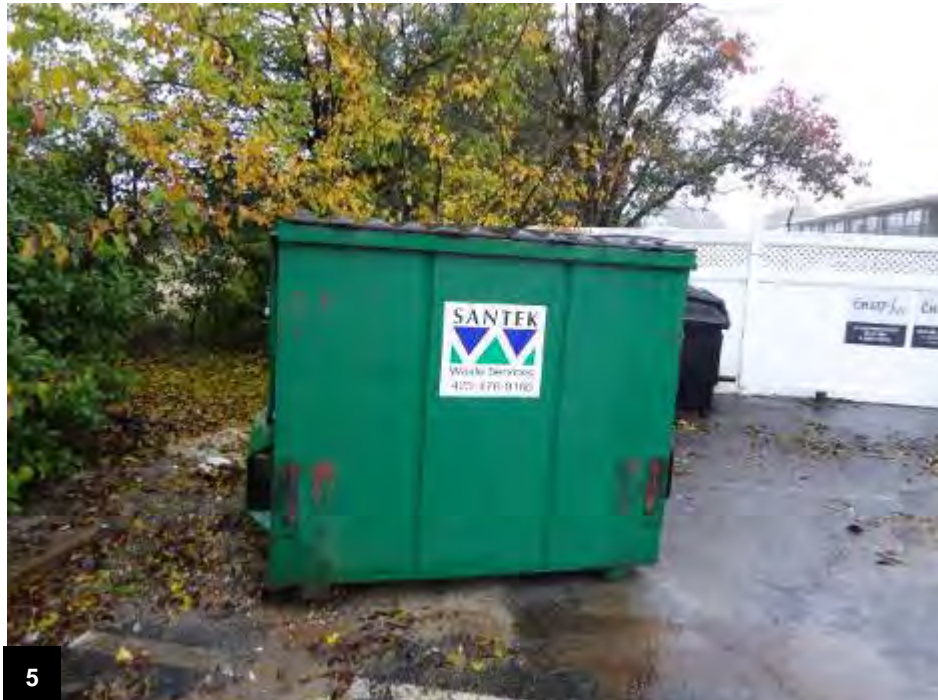
Typical non-hazardous solid waste container

Non-hazardous solid waste is disposed of in a dumpster and is removed from the Subject on a regular basis by Santek Waste Services. Potential sources of contamination, such as waste oil or auto batteries, were not observed in the vicinity of the dumpster.

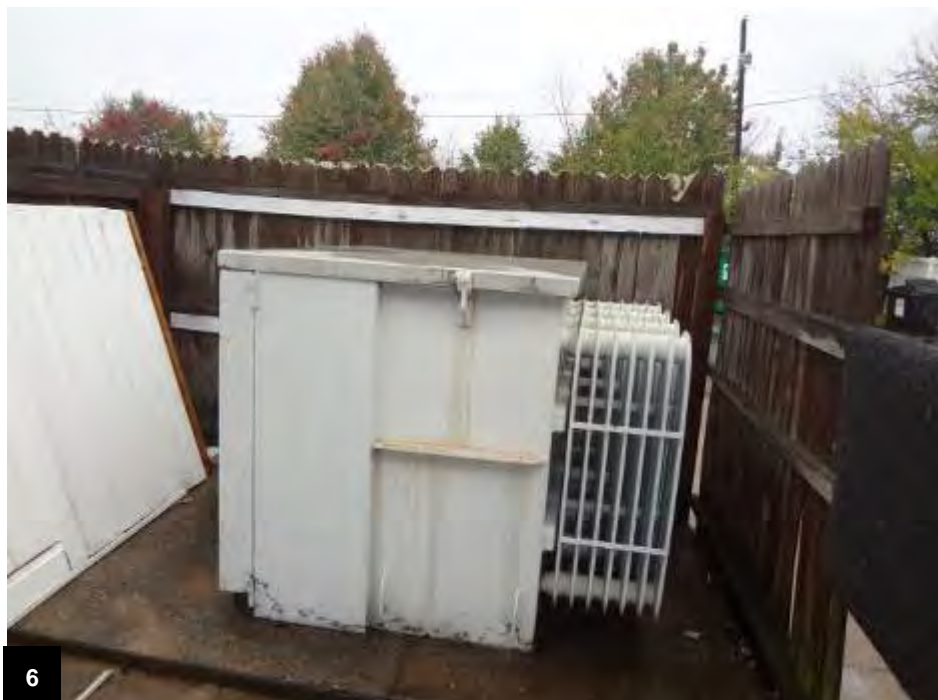
Utility-owned, pad-mounted transformer

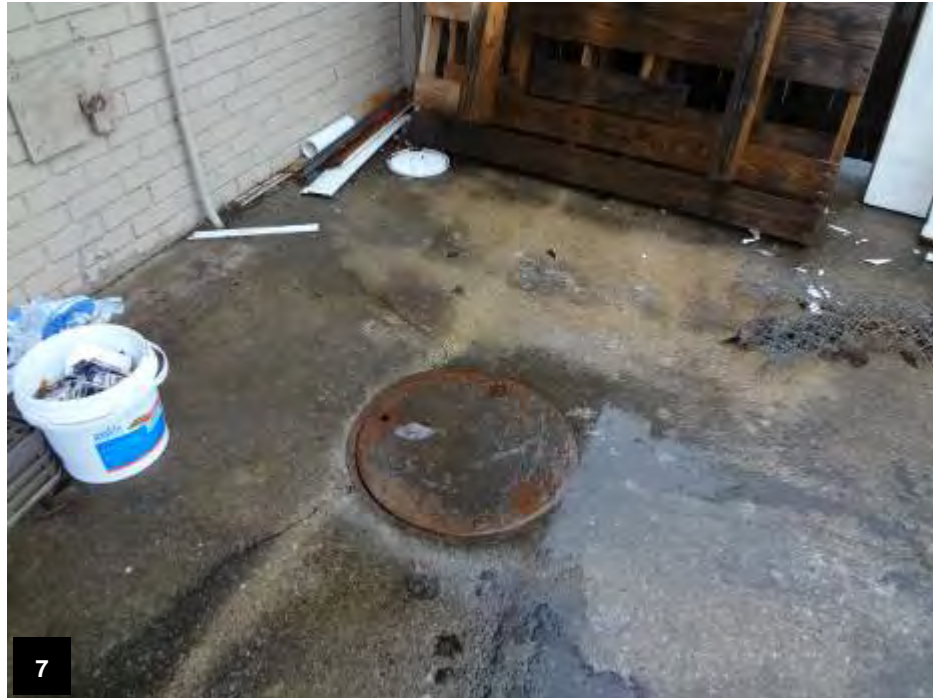
Grease trap adjacent to restaurant

A waste cooking grease container was observed at the Subject, adjacent to Home Slice Pizza. This container is emptied on a regular basis by Dar Pro Solutions and is not

With the exception of the waste cooking grease container and non-hazardous solid waste containers, DPS did not identify containers suspected of storing waste. With respect to the waste cooling grease and non-hazardous solid waste containers, no significant environmental concerns were noted.

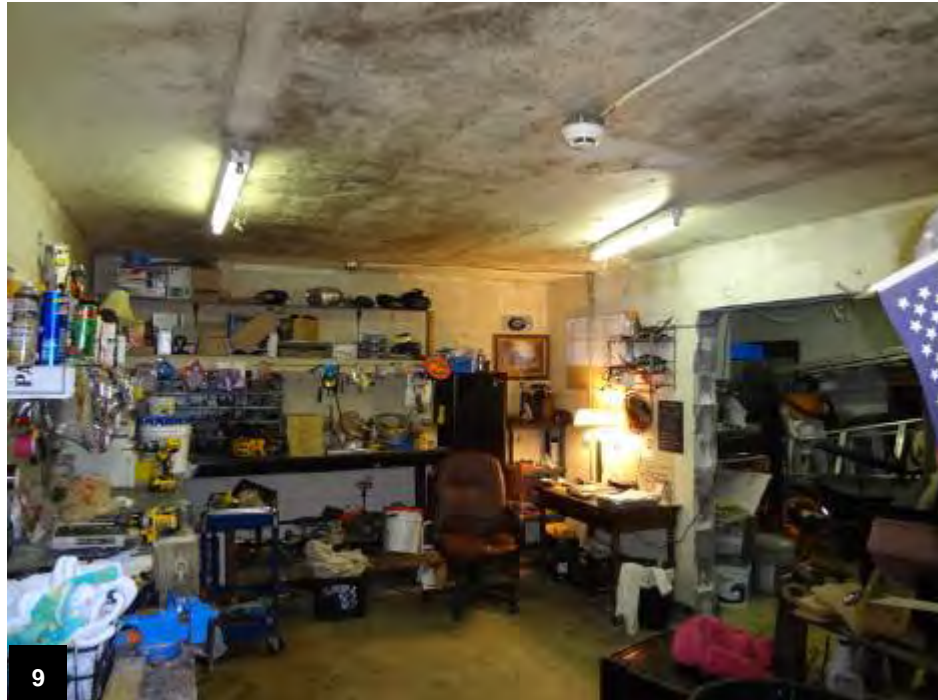
Building maintenance workshop

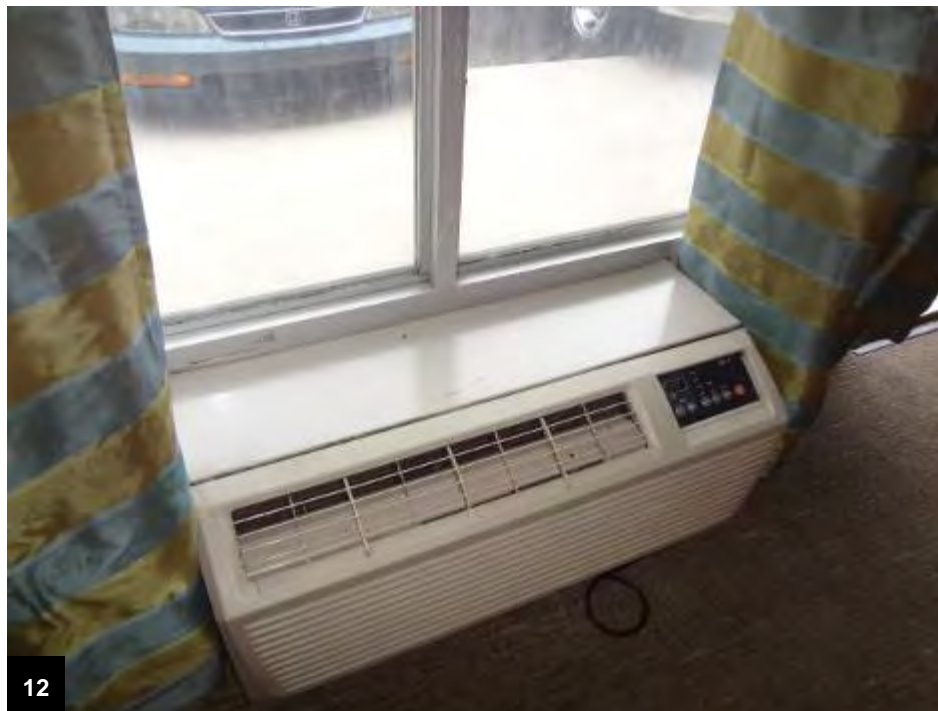
Typical PTAC unit in guestrooms

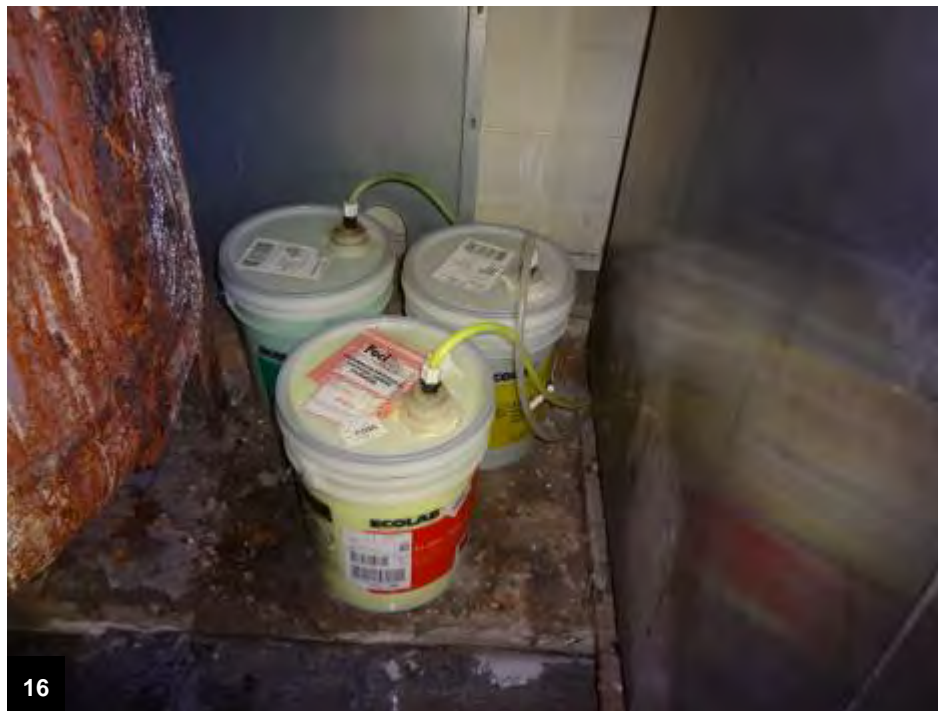
Commercial grade detergents in house laundry room

With the exception of chemicals customarily used for routine building and pool maintenance, as well as house laundry services, DPS did not observe any hazardous chemicals stored on-site. For the most part, the chemicals are stored in the maintenance room, pool filtration shed, or house laundry room. Of note, floor drains were not observed in the vicinity of the chemical storage areas. In addition, housekeeping was generally considered satisfactory. The chemicals, which are stored in their original containers, do not appear to represent an impact to the environmental quality of the site provided that they are used as intended, properly handled, and the regulations pertaining to their usage are followed.

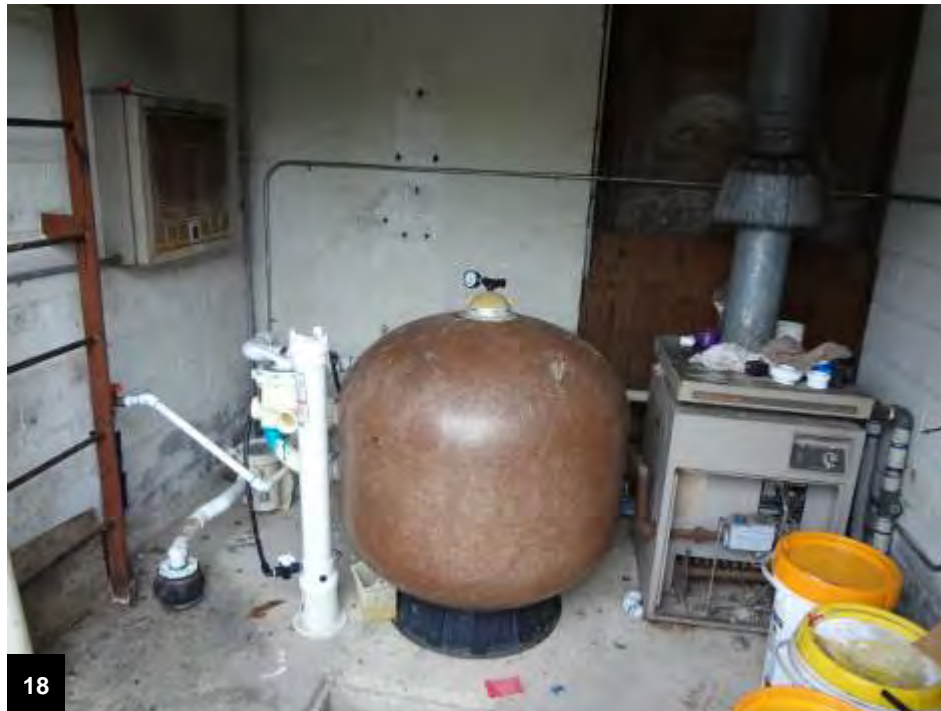
Pool filtration room

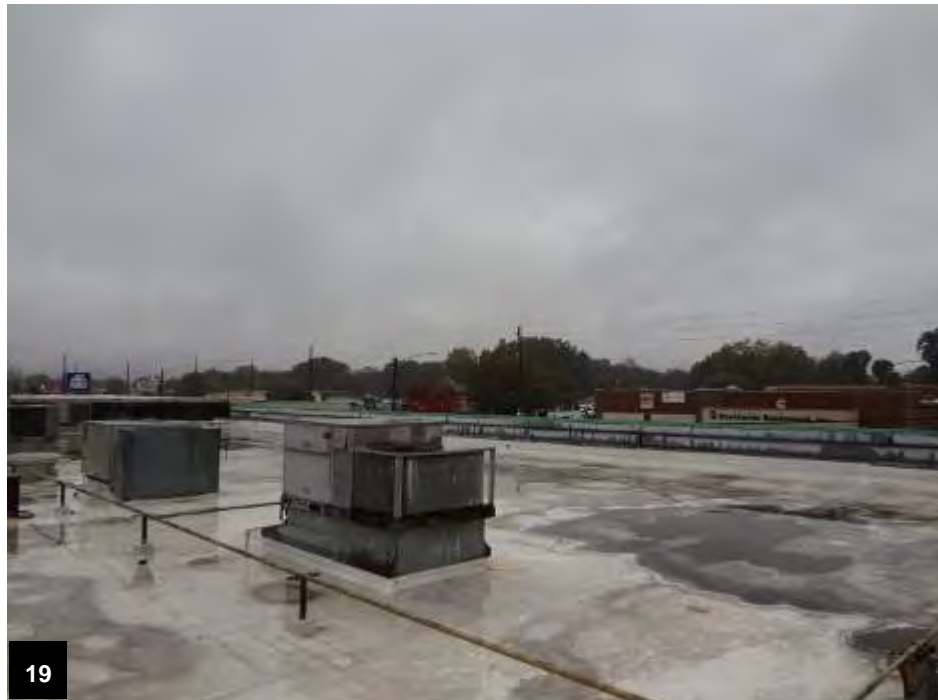
View of Subject's roof and HVAC package units

The Subject is improved with a 45-year old, 155-guestroom hotel, operating as The Chatt Inn. A restaurant occupies the easternmost tenant space of the building. Amenities include an outdoor pool, full kitchen, a courtyard area, and dining area. The two-story building was constructed in 1973 on a slab-on-grade foundation with a superstructure of concrete block and wood framing. Exterior walls feature stacked stone and painted brick. The roof is a TPO system with metal awnings surrounding the perimeter of the building.

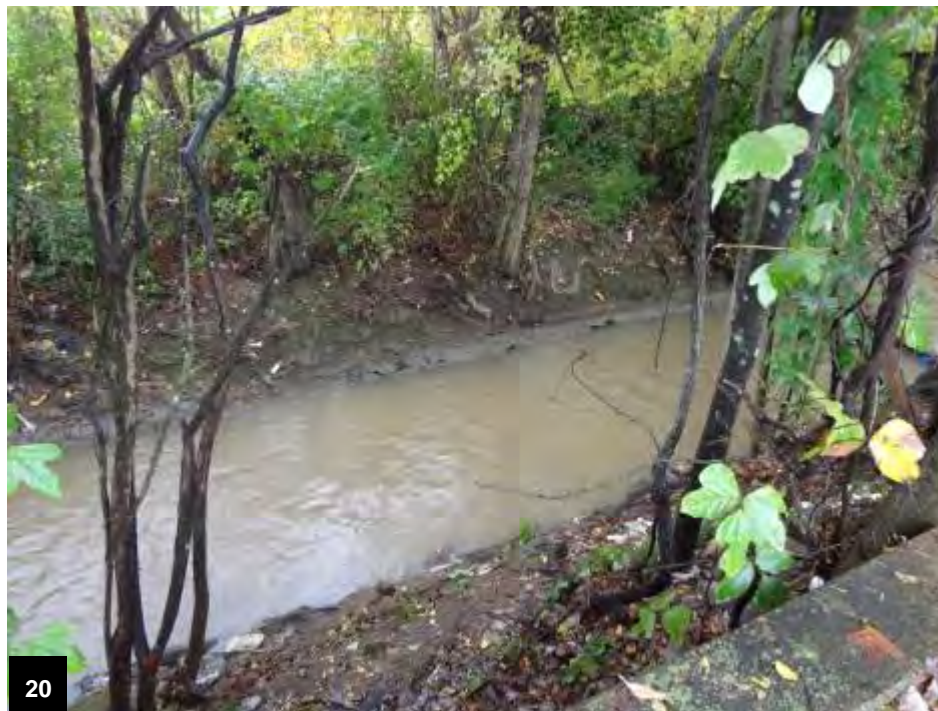
View of Dobbs Branch along southern property boundary

Under natural, undisturbed conditions, shallow groundwater flow generally follows the topography of the land surface and on this basis, the topography suggests that groundwater flow across the Subject is in a southerly direction towards Dobbs Branch. However, localized conditions can alter flow direction and thus the presumed flow may not coincide with the actual in the subject area. Shallow groundwater in the vicinity of the subject site is anticipated to be encountered at a depth of approximately 30 to 40' below ground surface.

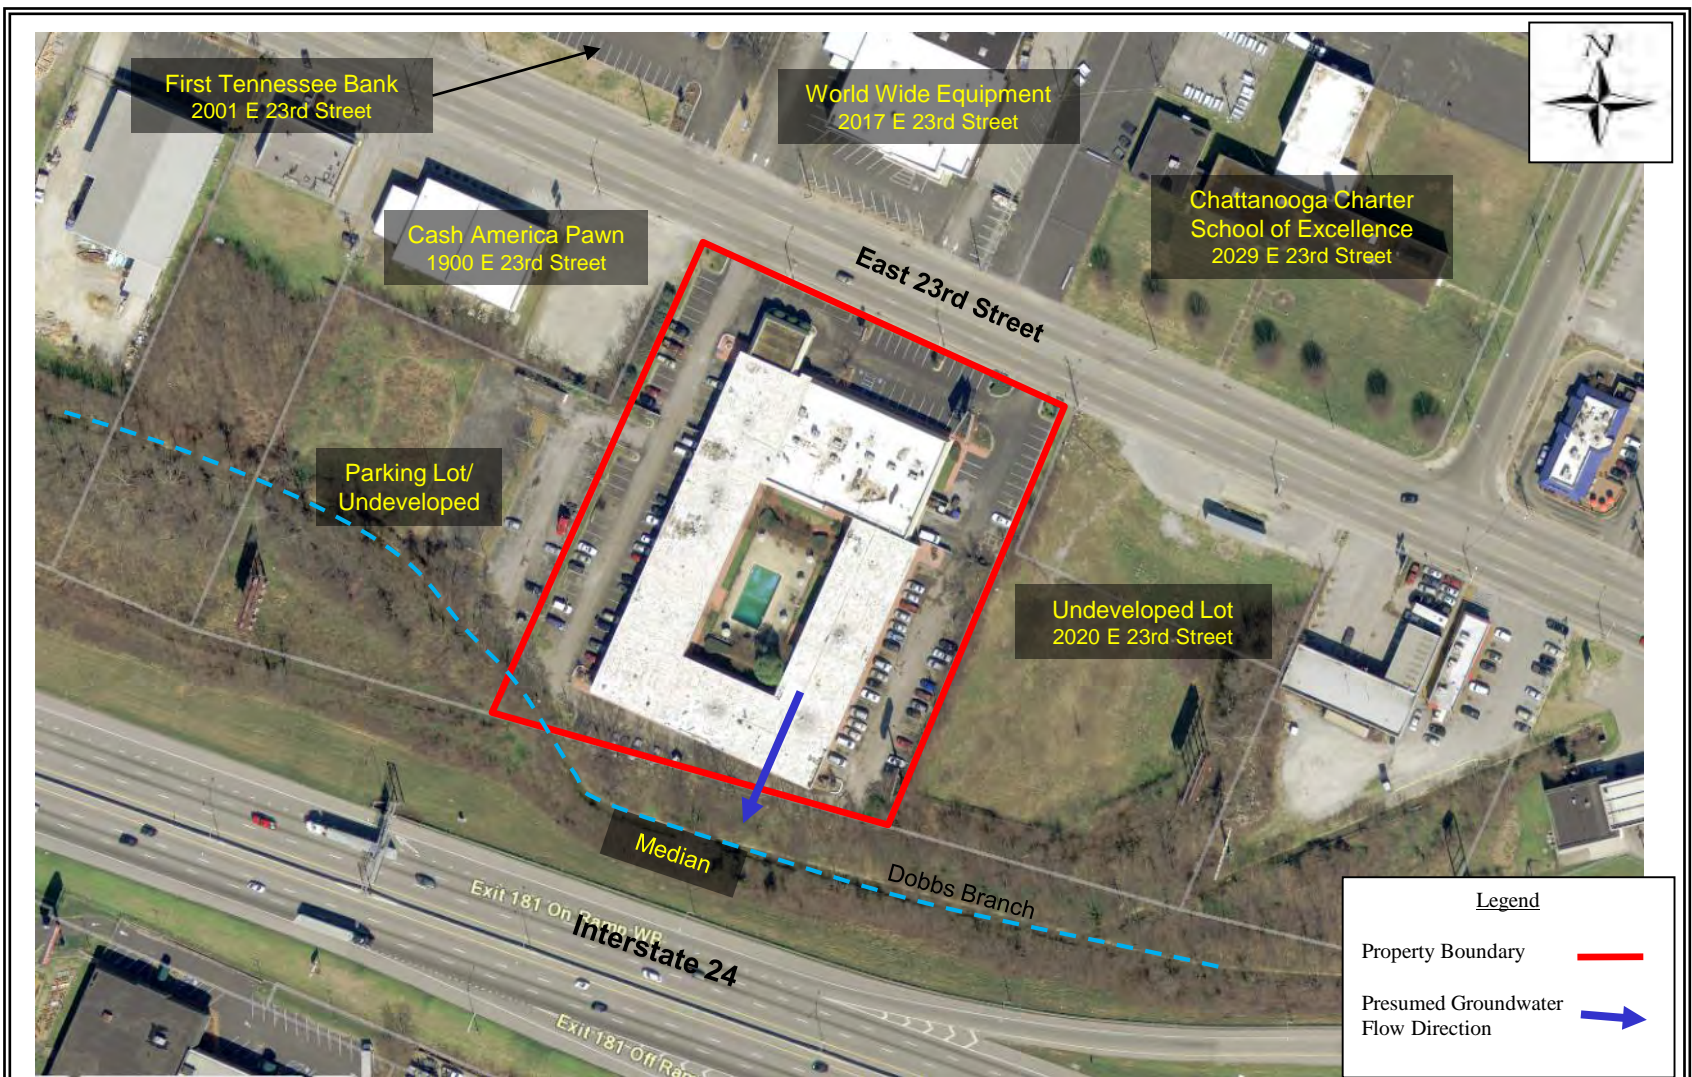
SITE PLAN

The Chatt Inn
2000 East 23rd Street
Chattanooga, Tennessee

Boundaries are approximate. Not to scale.
