PHASE I
ENVIRONMENTAL
SITE ASSESSMENT

RAMADA INN
2016 16TH AVENUE EAST
CORDELE, GEORGIA

June 28, 2019

Project M411-01

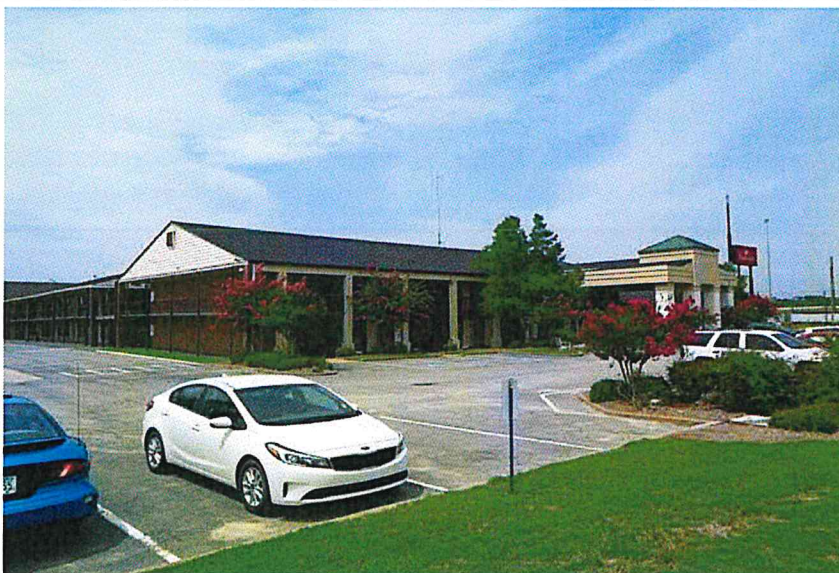
Photo 1
Hotel on the Subject Site
(Facing SW)

As mentioned above the site supported a Ramada Inn hotel. At the time of LOGIC's site visit, the hotel included three two-story hotel buildings. (See Photo 1, Attachment C.) According to tax assessor records, the hotel was built in 1965 and consists of 45,500 square feet. In total, the hotel had 103 active guest rooms, all of which had exterior accessibility. (See Photo 2.) Building A, the northernmost building, included the lobby, a restaurant, offices, restrooms and a few guest rooms. The lobby was a two story room with seating for guests and a service counter. (See Photo 3.) The restaurant had three separate dining rooms that were often used as meeting rooms or banquet halls. (See Photos 4 and 5.) The kitchen included three rooms. The front room had the cooking and cleaning stations. (See Photo 6.) The second and third rooms were mostly used for storage. (See Photo 7.) The office just off the lobby was also being used for storage. (See Photo 8.)

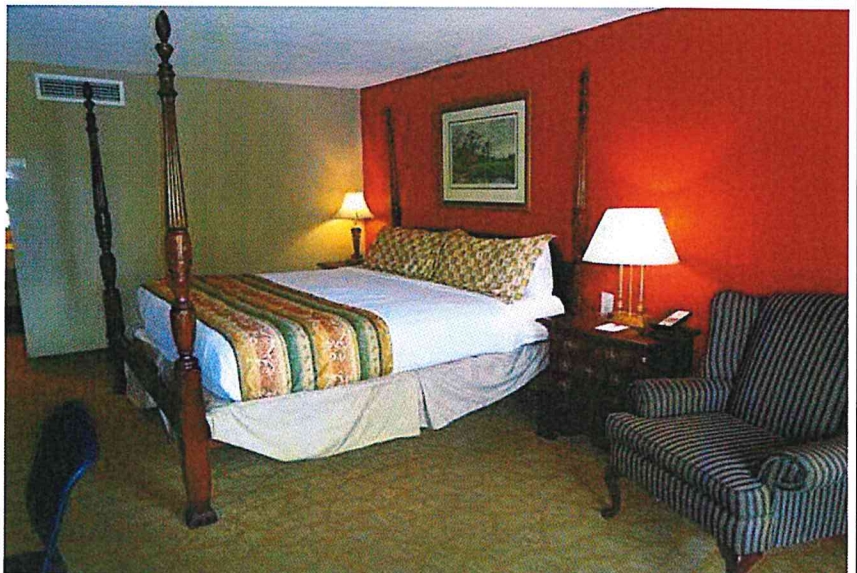
Photo 9
Guest Room

Building B, the easternmost building, was occupied by guest rooms. (See Photo 9.) Building C also had several guest rooms. However, the southeast corner of the building was occupied by the laundry room and maintenance room of the hotel. The laundry room consisted of multiple smaller rooms. Some of the rooms had laundry equipment others were used for storage or linen folding. (See Photos 10 and 11.) The maintenance room included several shelves for equipment and chemical storage. (See Photo 12.)

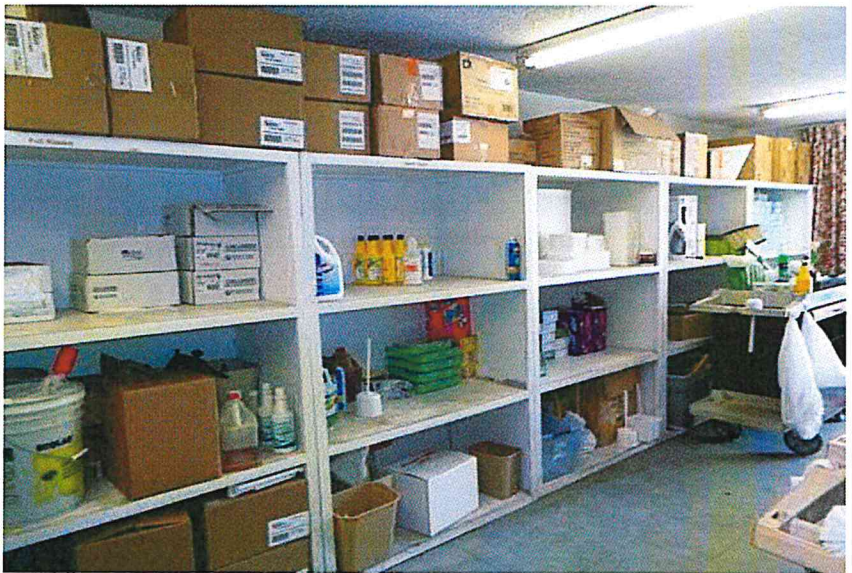
Photo 11
Laundry Room Storage

On site chemicals are generally limited to ordinary cleaning supplies, laundry and maintenance chemicals. These chemicals are stored in the laundry room, kitchen and the maintenance room of the hotel. (See Photos 10, 11 and 12.) All chemicals were stored in containers of less than five gallons, and no evidence of any chemical releases to the environment was visible during LOGIC's site visit. Any release of the chemicals stored on site would be in the form of small, localized spills inside the building. No threat to the site's soil or groundwater is indicated.

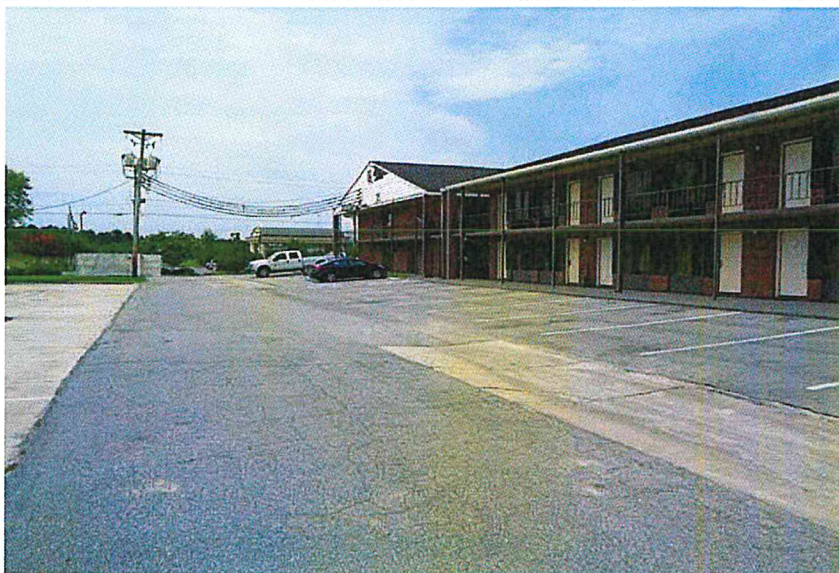
Photo 13
Paved Parking Lot
(Facing S)

The hotel was surrounded by a paved parking lot. (See Photo 13.) In the southeast corner of the parking lot was a dumpster in a corral. (See Photo 14.) In between the buildings was a fenced area with a pool. (See Photo 15.) Just south of the pool was a storm-water pump station. (See Photo 16.) The westernmost portion of the site was completely occupied by a gravel parking lot with a billboard in disrepair. (See Photos 17 and 18.)

Storm water from the paved areas flowed in sheets via shallow drainage ditches that traversed the parking lot in north-south formations. (See Photo 13.) The ditches discharged the storm water through cuts in the curbs to the south adjacent property. According to Mr. Bolton, the storm water from the buildings and the area around the pool was directed to several storm drains on the grass. (See Photo 19.) These drains directed water to a pump station that lifted the storm water to the municipal storm water system. (See Photo 16.)

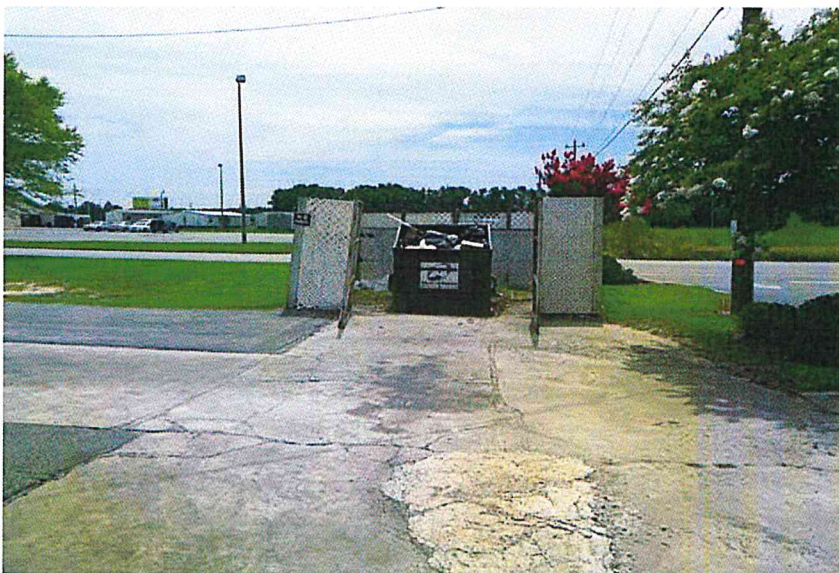
Photo 14
Dumpster Corral
(Facing E)

At the time of LOGIC's site visit, typical waste generation was limited to food waste, office trash (paper, packaging, etc.) and waste from guest rooms. This trash was accumulated in a dumpster near the southeast corner of the site. (See Photo 14.) According to Ricky Bolton, an in-ground grease trap was located behind the restaurant. A small amount of surface debris was identified around the site, particularly below the billboard in the gravel parking lot. The debris mostly included wood, drywall and tarp. (See Photo 18.) No long-term threat to the site appeared likely from the debris. Historically, the gravel lot had been used for semi-truck and trailer parking. No evidence of waste burial or other on-site disposal was encountered. None of the debris suggested a threat to the soil or groundwater.

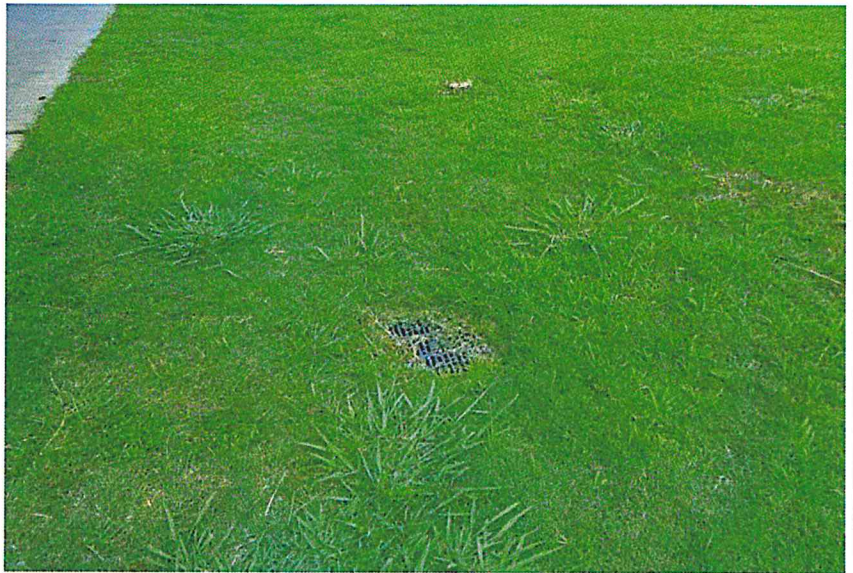
Photo 19
Catch Basin
(Facing W)

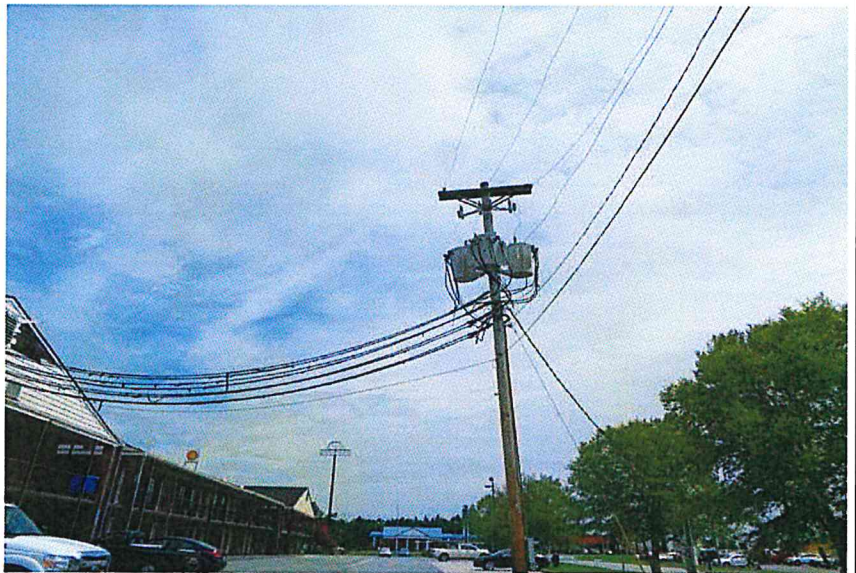
Photo 20
On-Site Transformers
(Facing N)

Electrical power was supplied to the site by aboveground lines. The site supported three pole-mounted transformers near the southeast corner of the site. (See Photo 20.) The transformers appeared to be in good condition and no evidence of release was noted. The

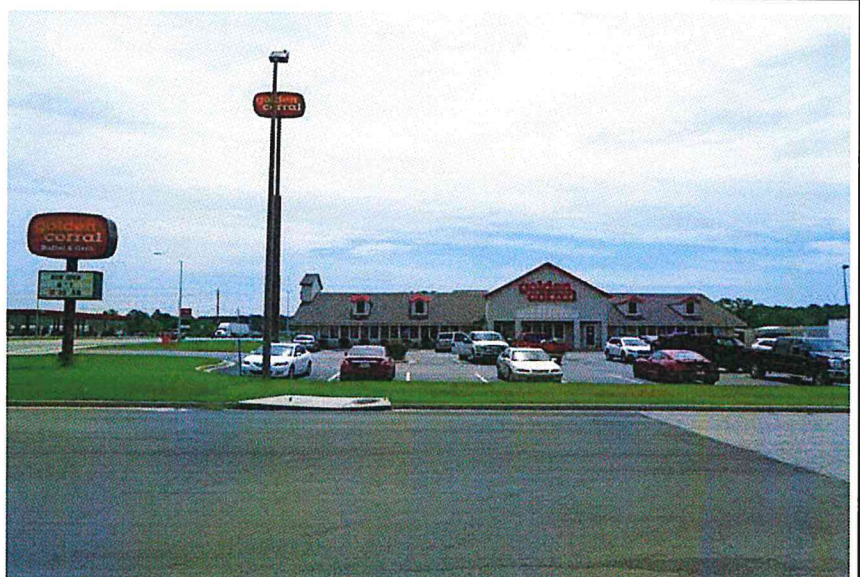
Photo 21
East Adjacent Property
(Facing E)

The site was bound to the east, across Arc Way Avenue, by Golden Corral. (See Photo 21.) As early as 1951, this property supported an orchard. The orchard remained until 2003, when the current restaurant was built. Based on the history of the property, no threat to the subject site is likely.

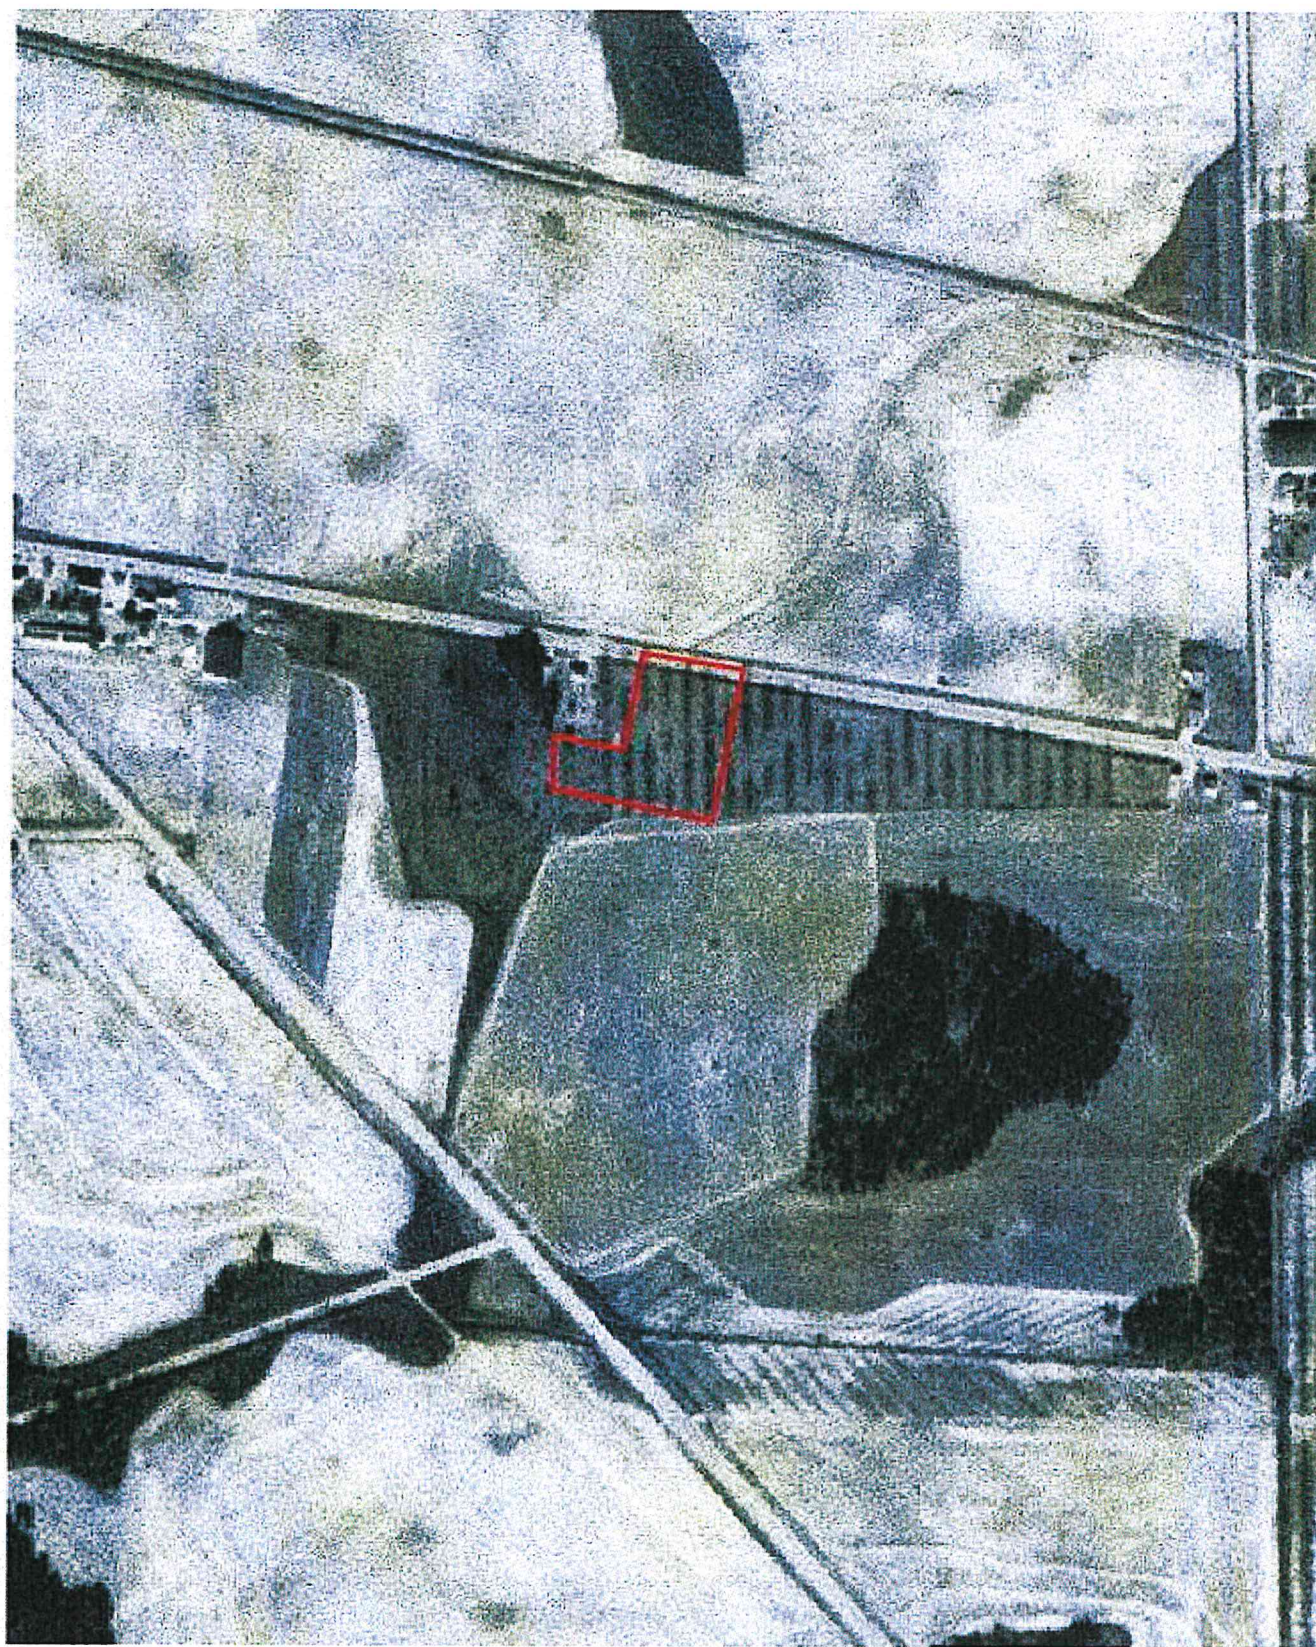
ATTACHMENT E-1 AERIAL PHOTO (1951)

The earliest historical documentation found during LOGIC's investigation was an aerial photo from 1951. In the photo, the subject site appears to support farmland or possibly an orchard. No development or structures can be seen on the site at that time. At that time, 16th Avenue East formed the site's northern boundary. In January 1963, via a deed of gift, Charles Greer transferred the subject site (with several other non-contiguous tracts) as part of a 54-acre parent parcel to Charles Greer, Jr. The deed references Interstate 75, which had been built around this that time. According to tax assessor records, the current on-site hotel was built in 1965. A deed of lease indicates the hotel was branded Ramada at that time. In an aerial photo from 1968, the hotel can be seen on the site. The southwest corner of the site appears to support a detention pond. No other structures can be seen on the site. The 1951 and 1968 aerial photos are included as Attachments E-1 and E-2, respectively.
